Expert Opinions of William L. Hall

Duarte, et al. v. United States Metals Refining Co.,
et al.

In the U.S. District Court for the District of New
Jersey 2:17-cv-01624

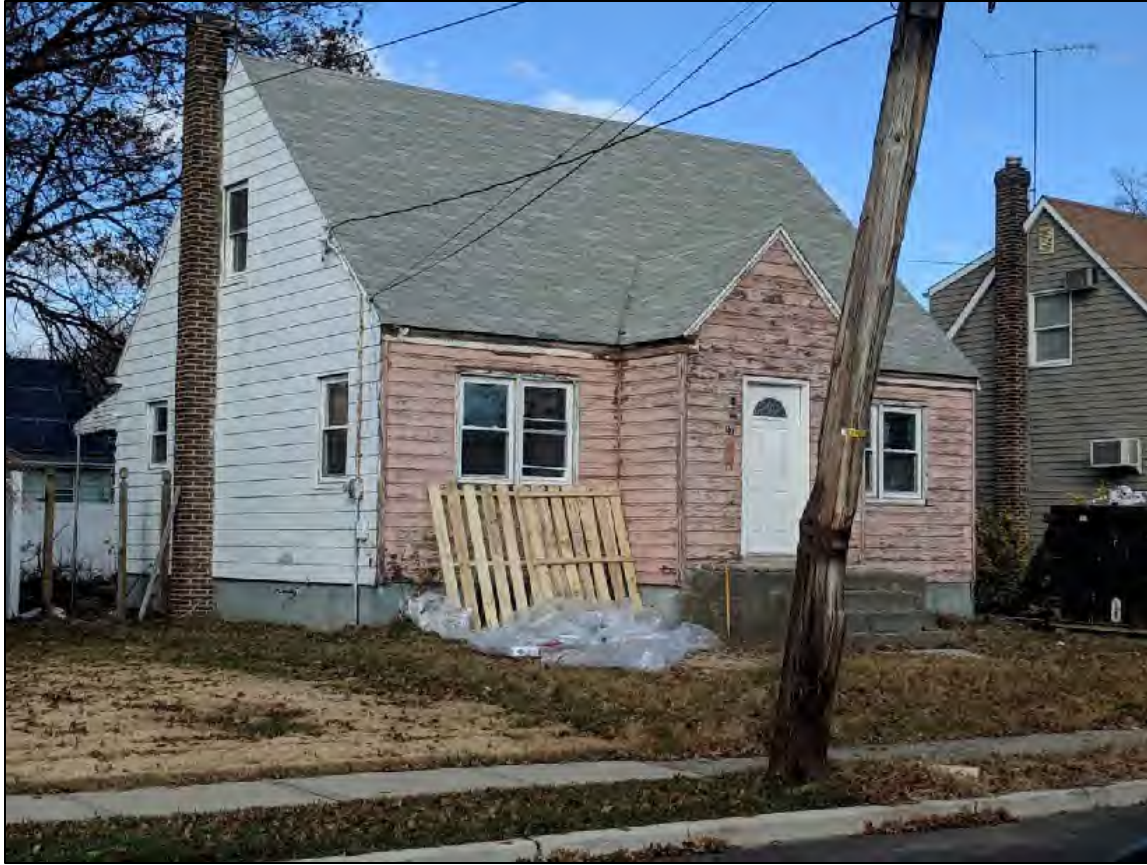
Figure 3-16. Renovated house showing painted surface underneath siding

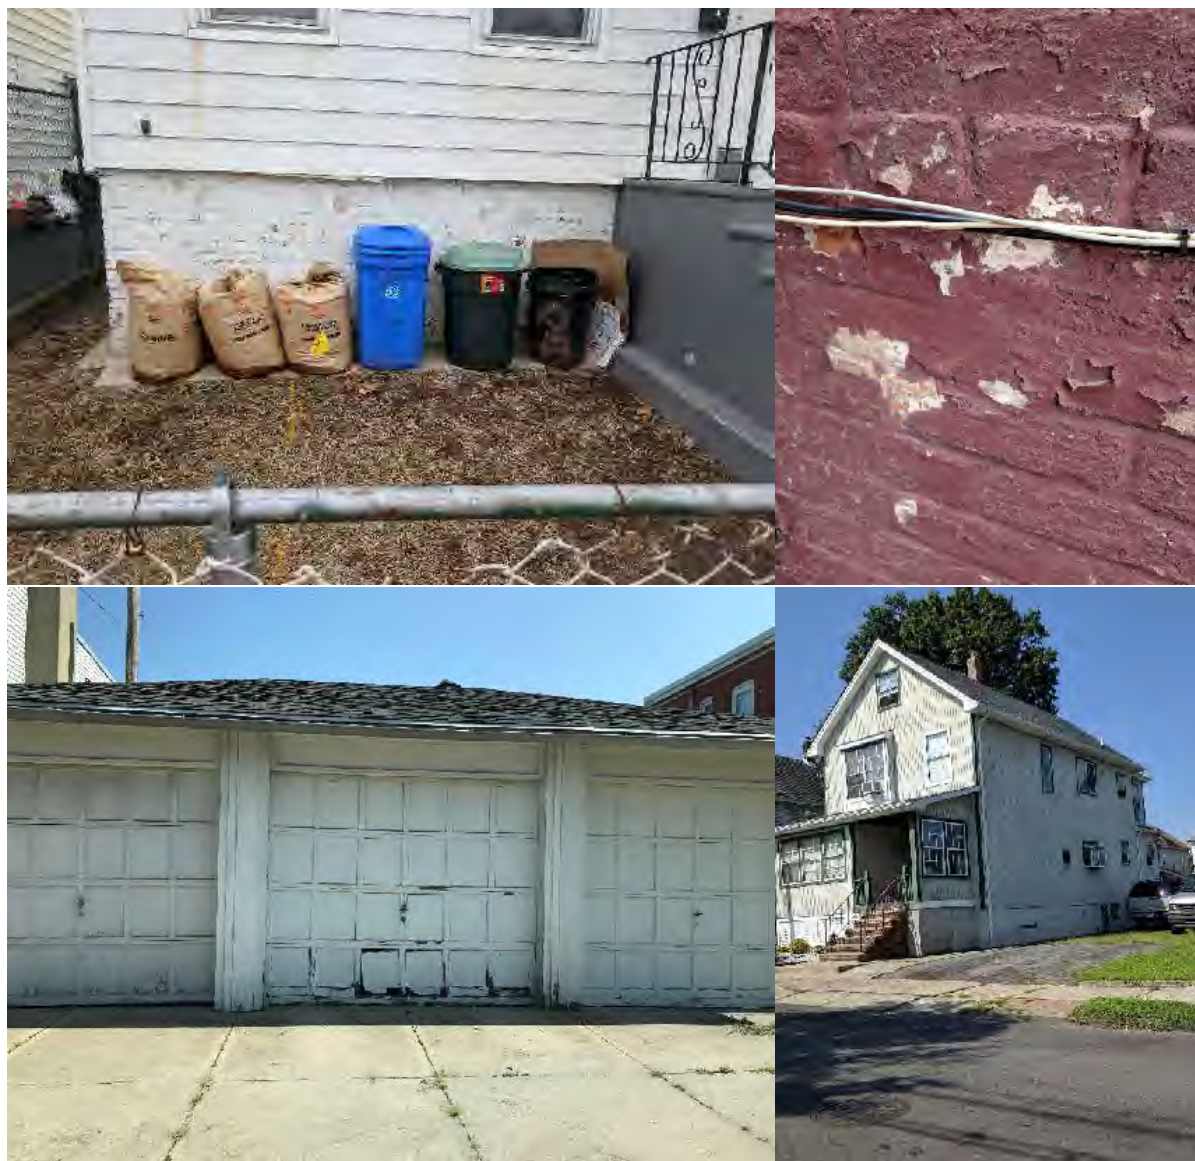
Figure 7-4. Examples of Peeling Paint observed in Carteret

NewFields personnel conducted two rounds of street-level property inspections within the proposed class area. The first round of property inspections covered 550 properties across the entire proposed class area and the second round focused on the 38 transect properties sampled by USMR. During both rounds of property inspections, any signs of peeling or chipping paint on a property were noted. Of the 550 properties inspected during the proposed class-area wide property inspection, 152 (28%), of the class-wide properties and 16 of the 38 (42%) USMR transect properties had visible signs of peeling paint. This number is likely an underestimate as the property inspections were conducted from the sidewalk or street, limiting the portions of the property that were visible. Examples of properties with peeling paint are shown in Figure 7-4.

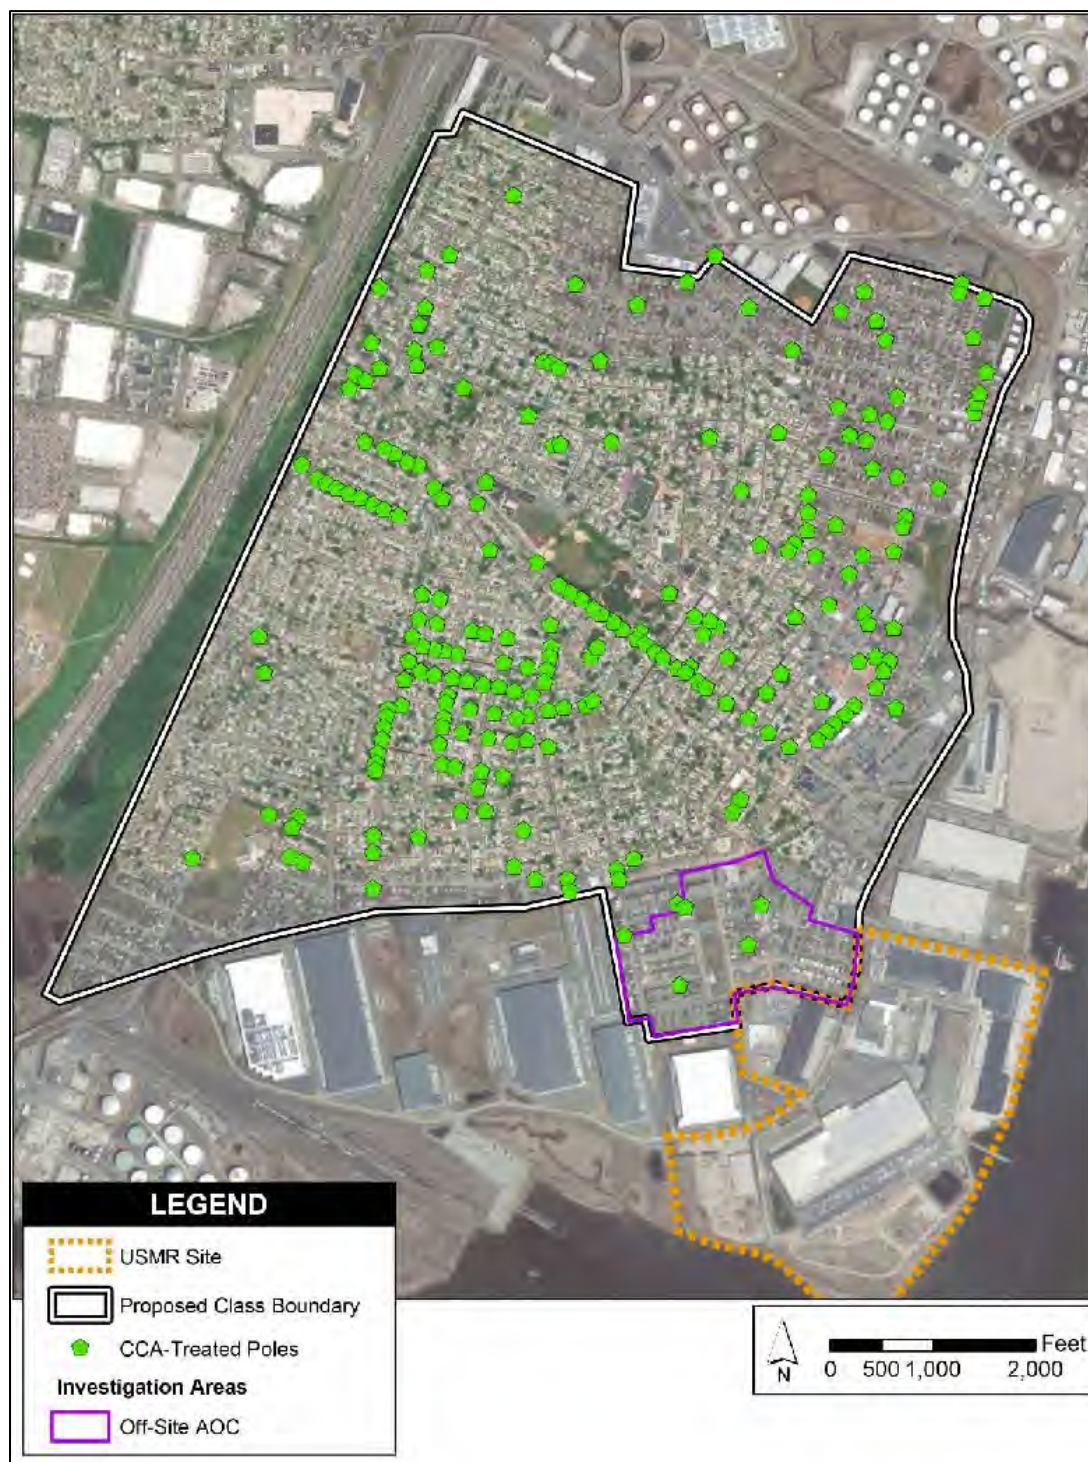
Figure 7-17 – Utility Poles Treated with CCA

and other industrial uses.² Currently, around 70% of homes in the United States have decks or porches containing pressure-treated wood.³ CCA-treated utility poles are ubiquitous in the proposed class area as seen in Figure 7-17 (also provided below), and CCA-treated wood was positively identified at the named plaintiffs' homes. Since its phase out for residential use in 2003, CCA has been replaced by other preservatives that still contain copper, including ammoniacal copper quaternary and copper azole.⁴ Stook et al (2005) found that more copper leaches out of the arsenic-free alternatives than CCA.⁵ Inspection of the proposed class area (including samples from the named plaintiffs' homes) documented the common use of copper and arsenic containing treated wood.

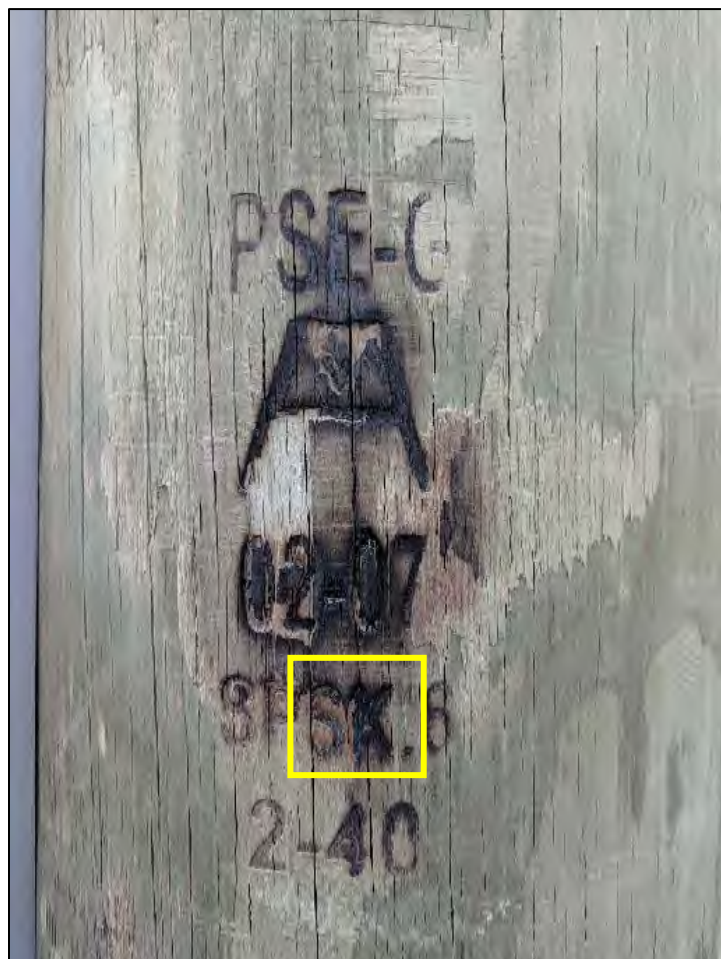
Figure 7-18. Photo of markings on CCA-treated utility pole at 29 Ash Street.

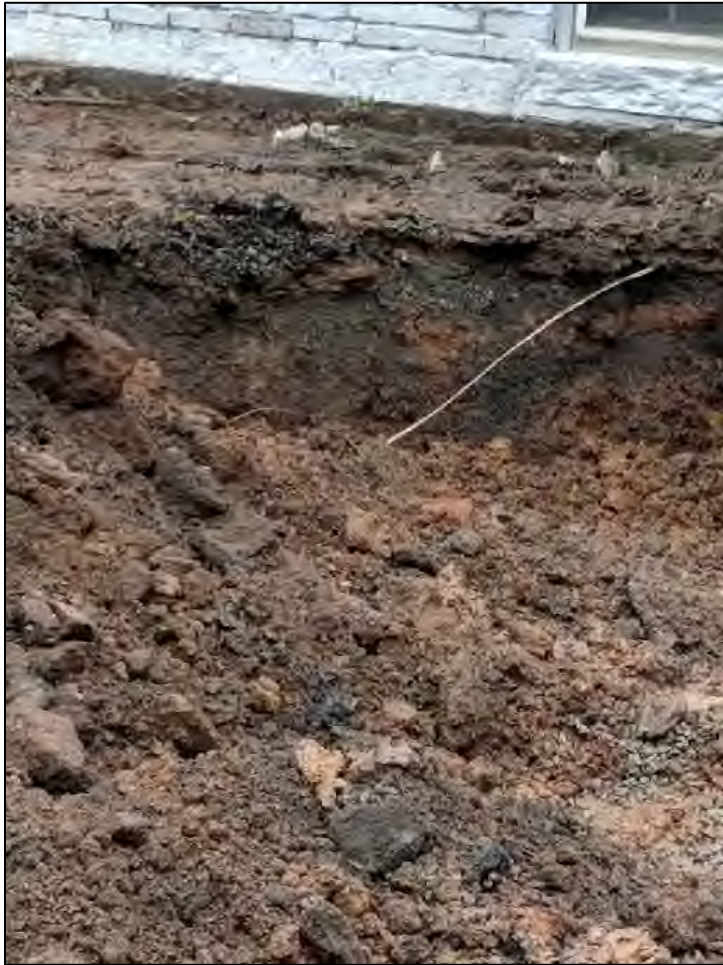
Figure 7-29. Slag observed during excavation of PPIN 4063.

(15 Edwin Street) and 4063 (14 Passaic Street), and visually observed fill materials at both properties. A layer of slag was observed in the excavation at PPIN 4063 (Figure 7-29). This slag was a light, pumice-like slag and its appearance was not consistent with smelter-derived slags I have observed at other smelter sites.
